**APPENDIX FOR THE AREA IN NEED OF
INVESTIGATION REPORT FOR**

685 MT. KEMBLE AVE (“GLEN ALPIN”)
679 MT. KEMBLE AVENUE (“HURSTMONT”)

February 2019

Prepared by Heyer, Gruel & Associates

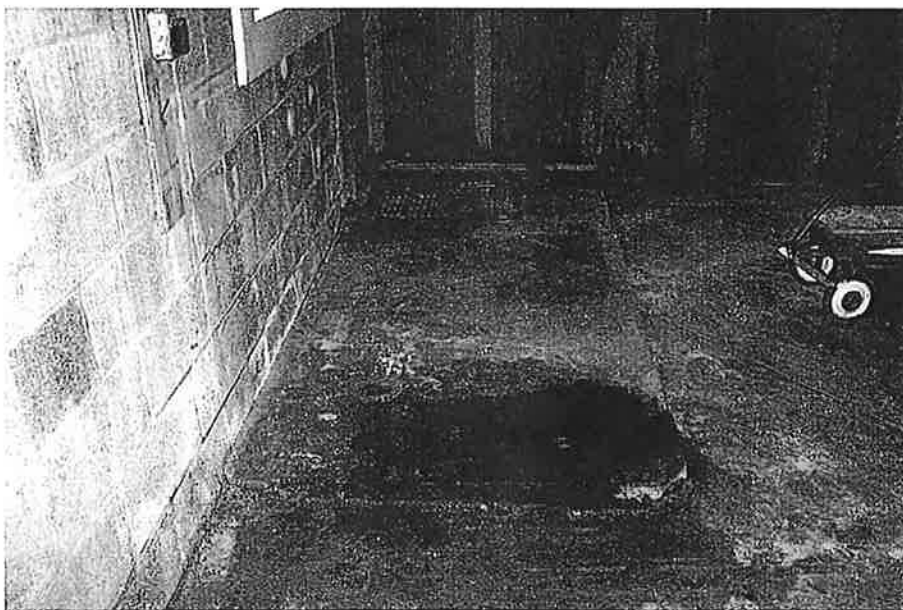
6. Area of staining near northern garage wall

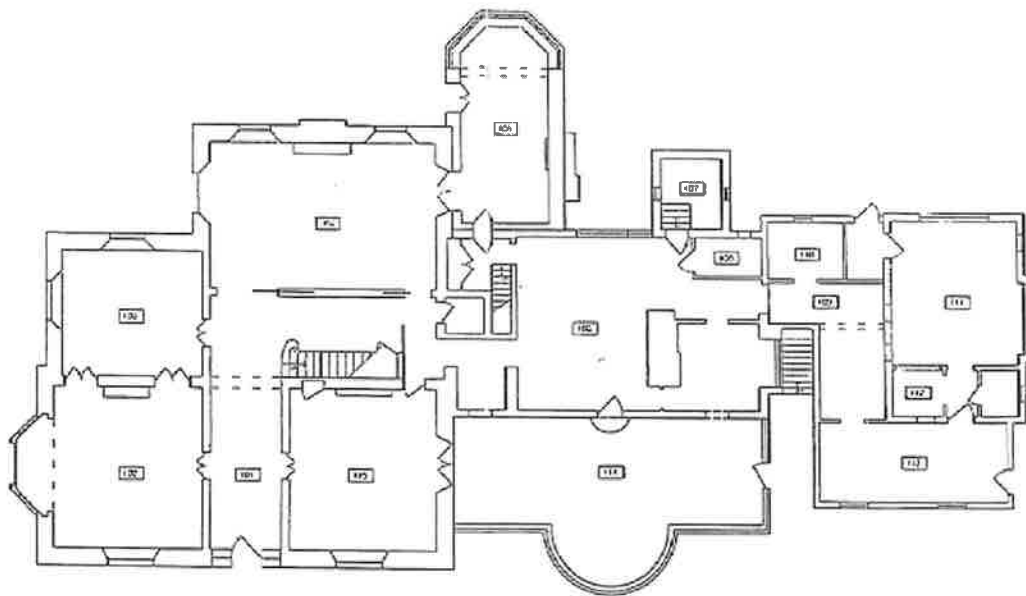
FIRST FLOOR PLAN
SCALE: 3/32" = 1'-0"

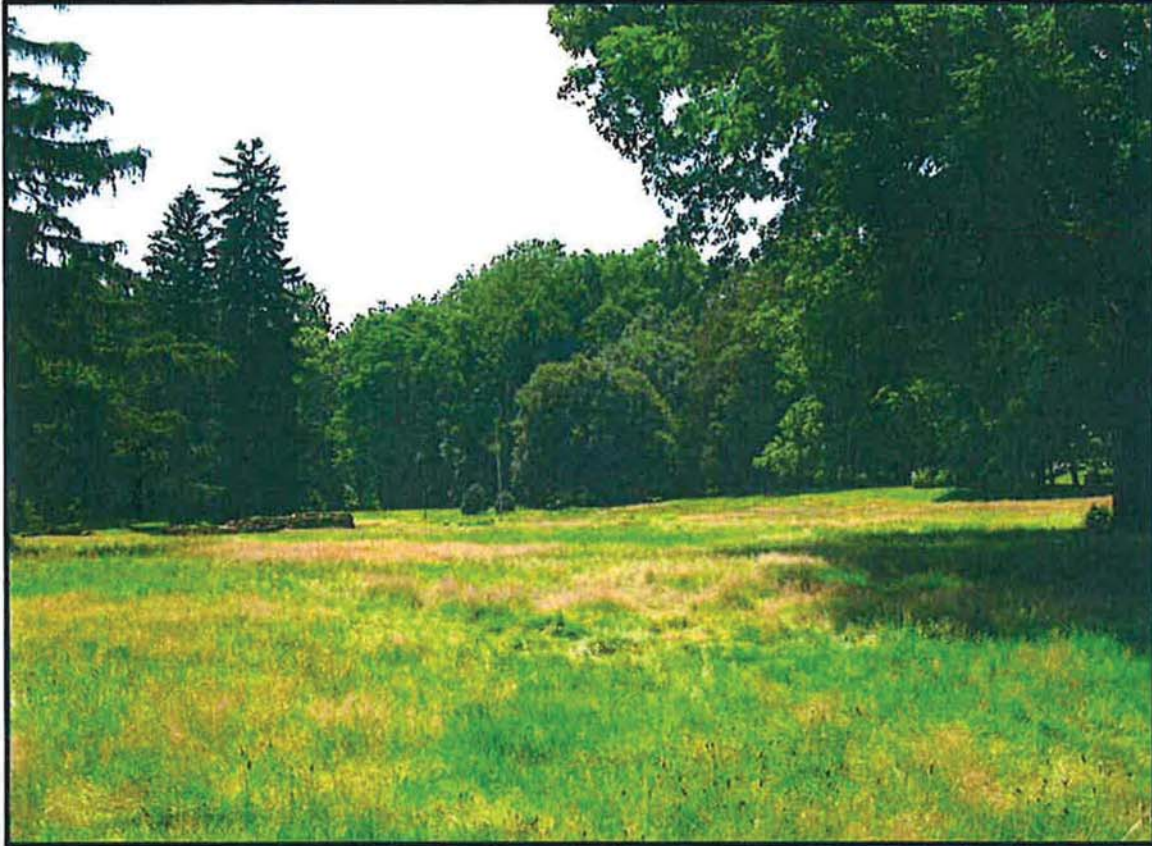
Plate 2. View west showing the area subjected to geophysical investigation in the front lawn of Glen Alpin (out of frame to the right) (Photographer: James Lee, August 2006) [HRI Neg.#06023/D2:02].

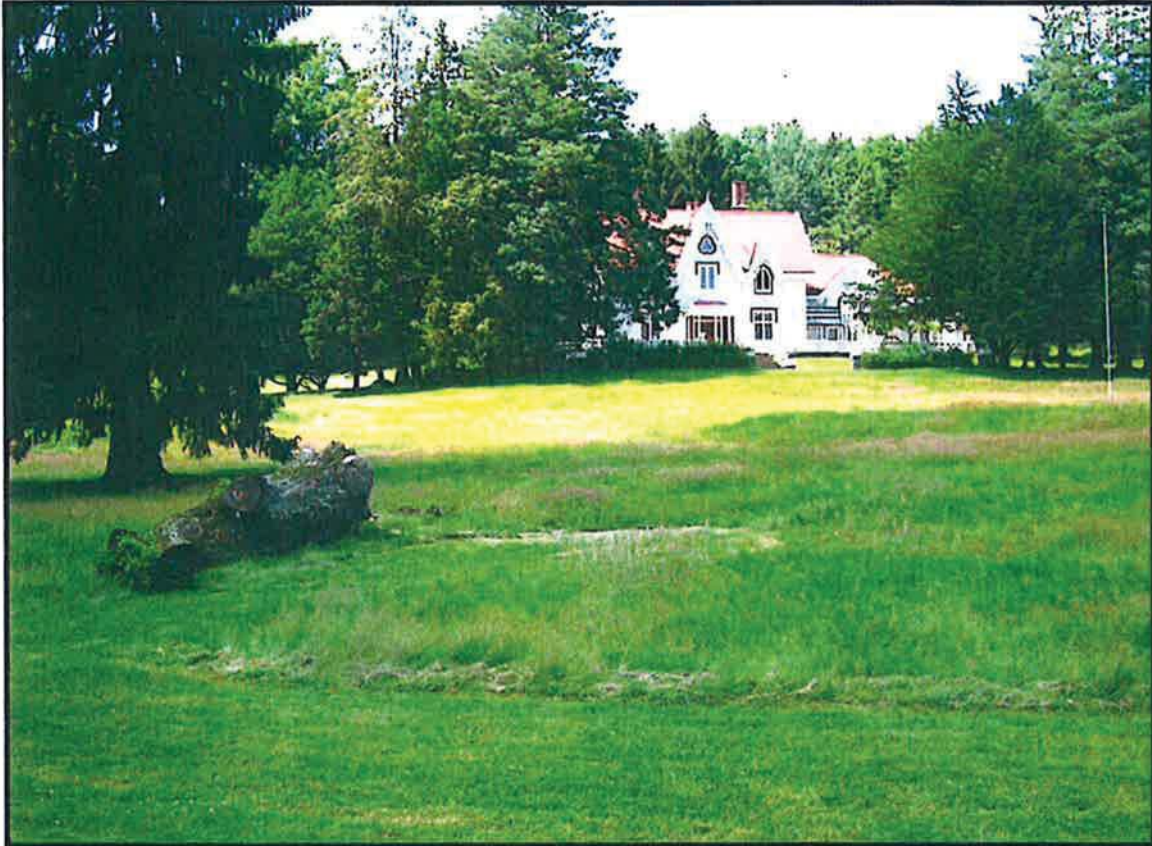
Plate 3. View northwest showing the area subjected to geophysical investigation. The Kemble family burial plot is located in the foreground of the photo near the fallen tree (Photographer: James Lee, August 2006) [HRI Neg.#06023/D2:09].

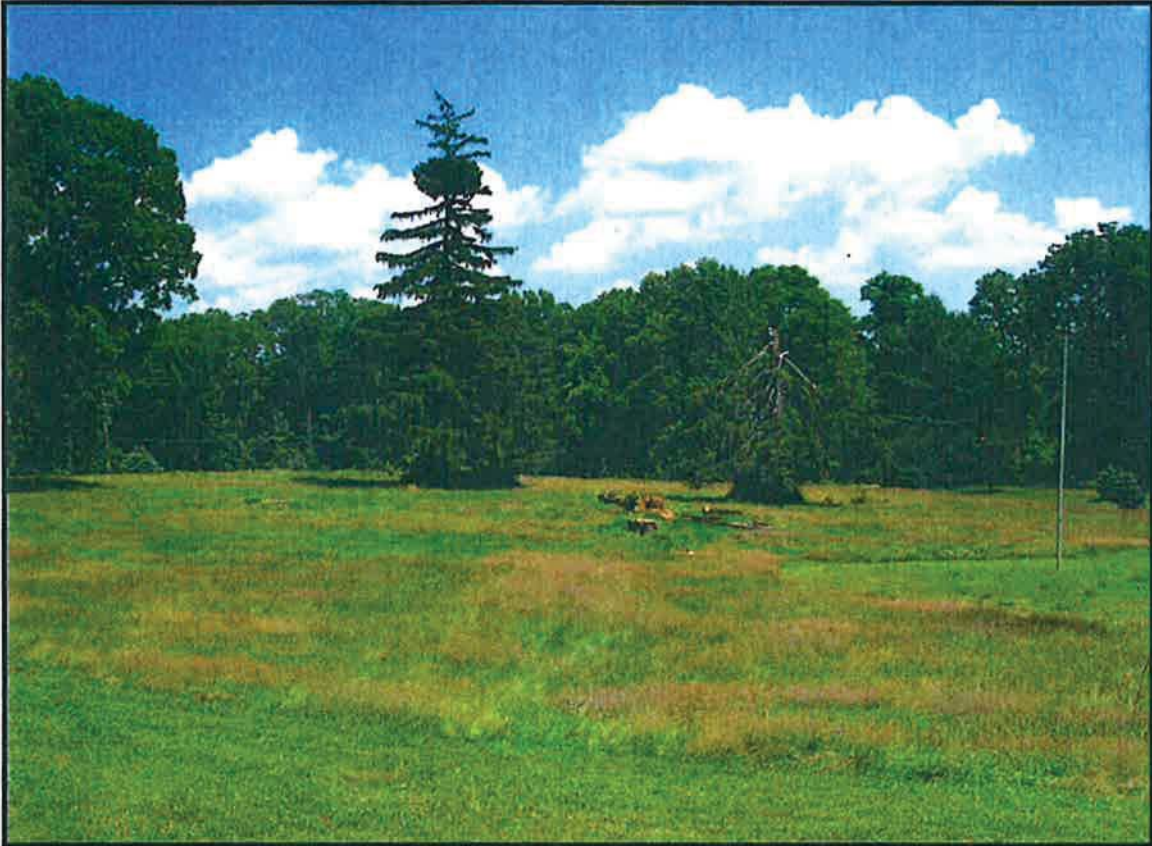
Plate 4. View southeast from the front of the Glen Alpin house showing the area subjected to geophysical investigation and shovel testing (Photographer: James Lee, August 2006) [HRI Neg.#06023/D2:33].

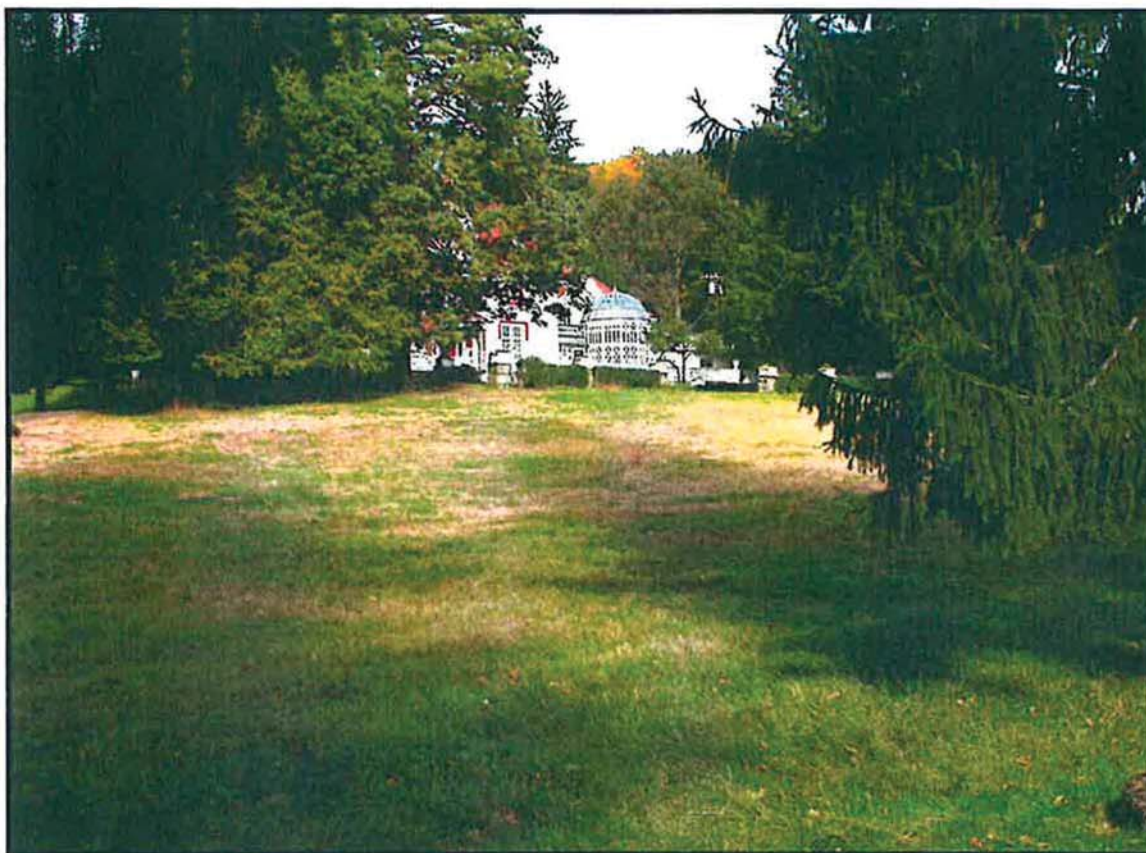
Plate 5. View north showing the area of the proposed septic installation (Photographer: James Lee, October 2005) [HRI Neg.#05054/D1:22].

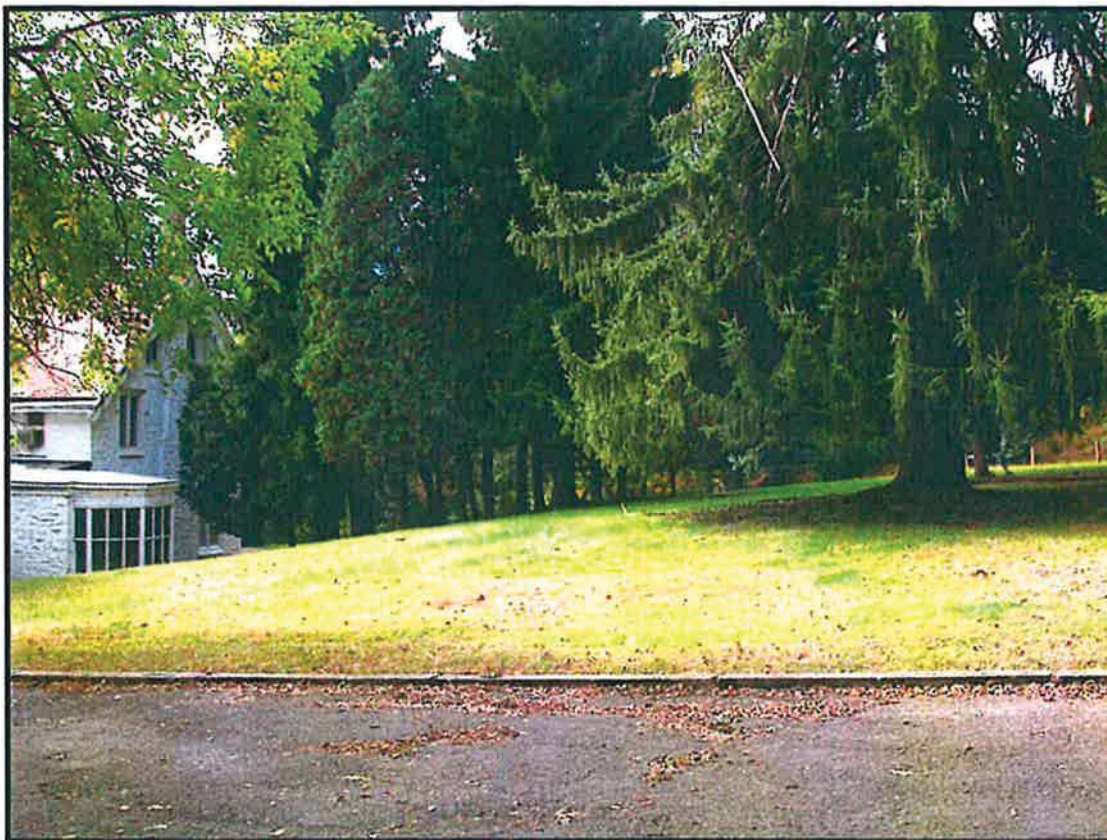
Plate 6. View south showing the reserve area of the proposed septic installation (Photographer: James Lee, October 2005) [HRI Neg.#05054/D1:03].

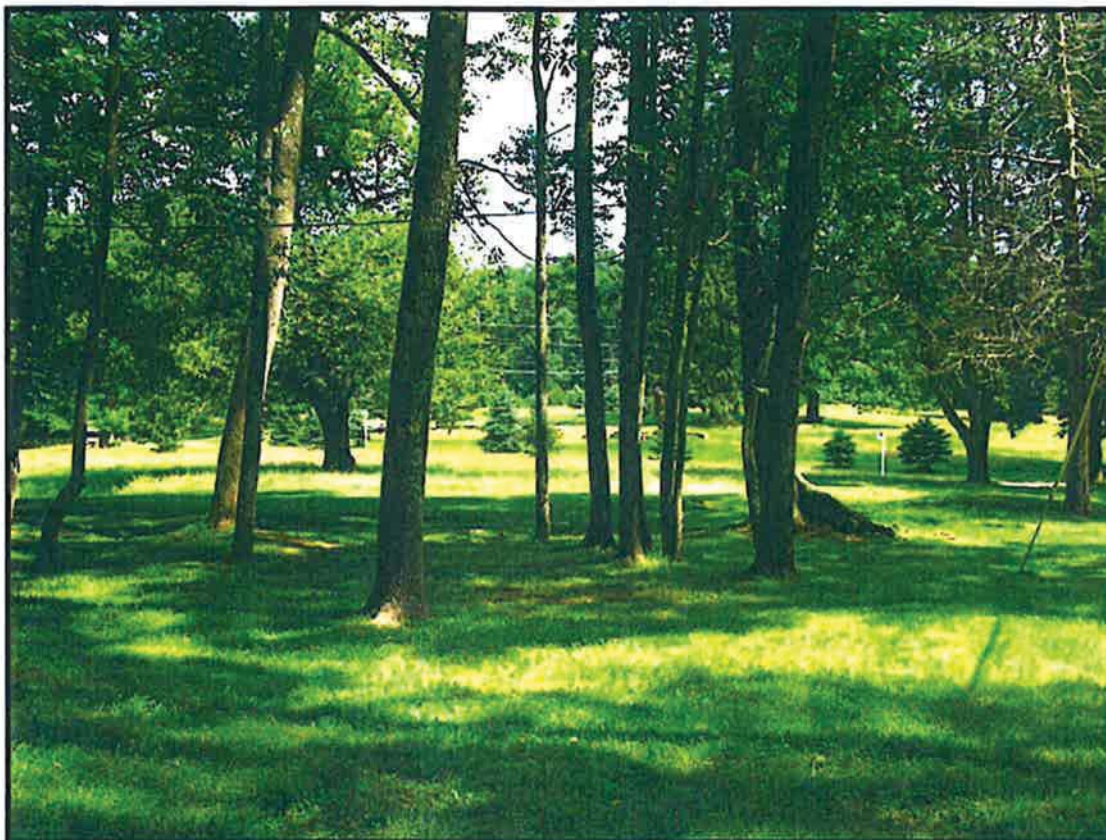
Plate 7. View east showing the location of the proposed parking northeast of the house and Shovel Tests 34-51 (Photographer: James Lee, August 2006) [HRI Neg.#06023/D2:25].

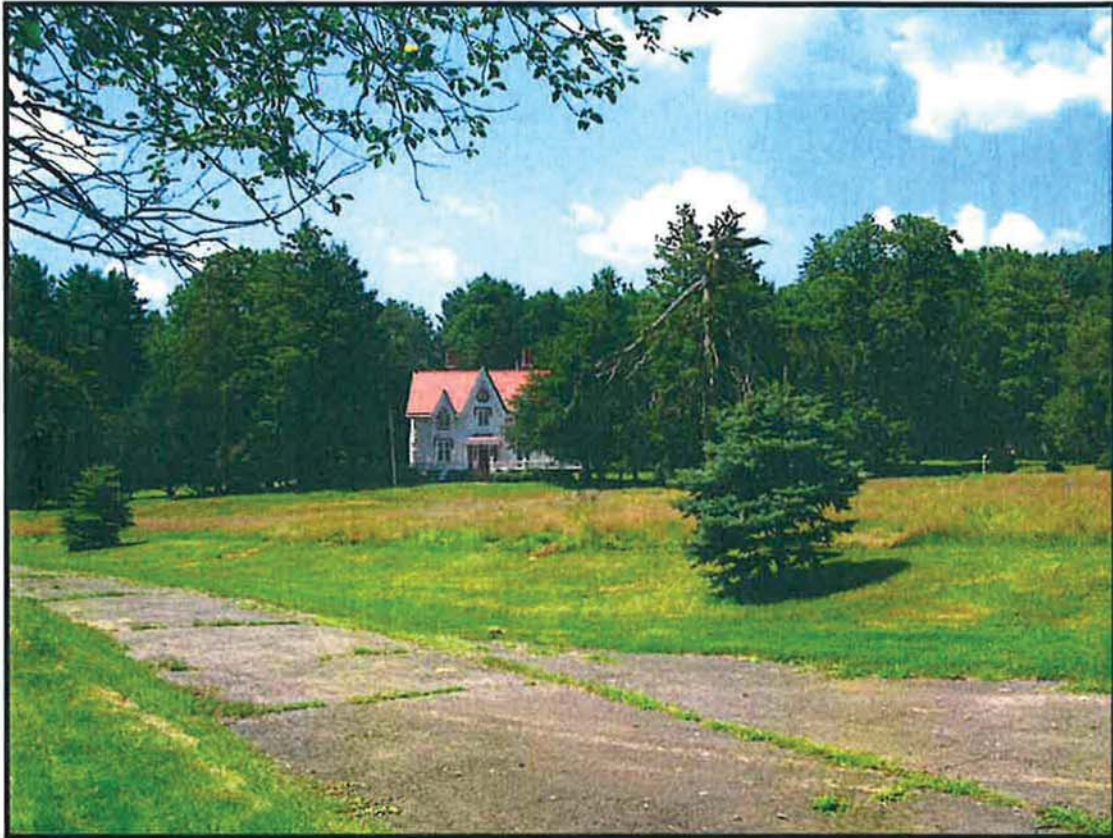
Plate 8. View northwest showing the location of a subsurface anomaly that may represent the subsurface remnants of a Kemble-period outbuilding site. This view also shows the baseline for Shovel Tests 52-93 excavated within the front yard (Photographer: James Lee, August 2006) [HRI Neg.#06023/D2:14].

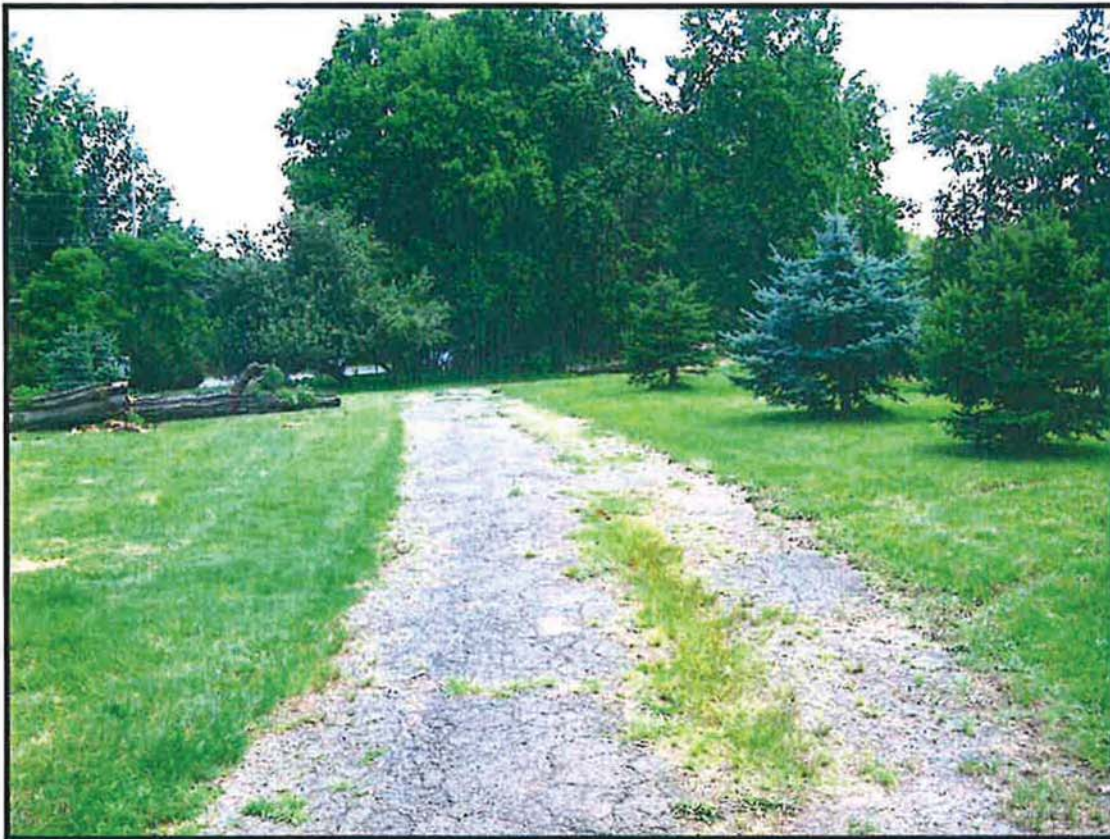
Plate 9. View south along the road in the front lawn where Shovel Tests 100-128 were excavated (Photographer: James Lee, August 2006) [HRI Neg.#06023/D2:22].

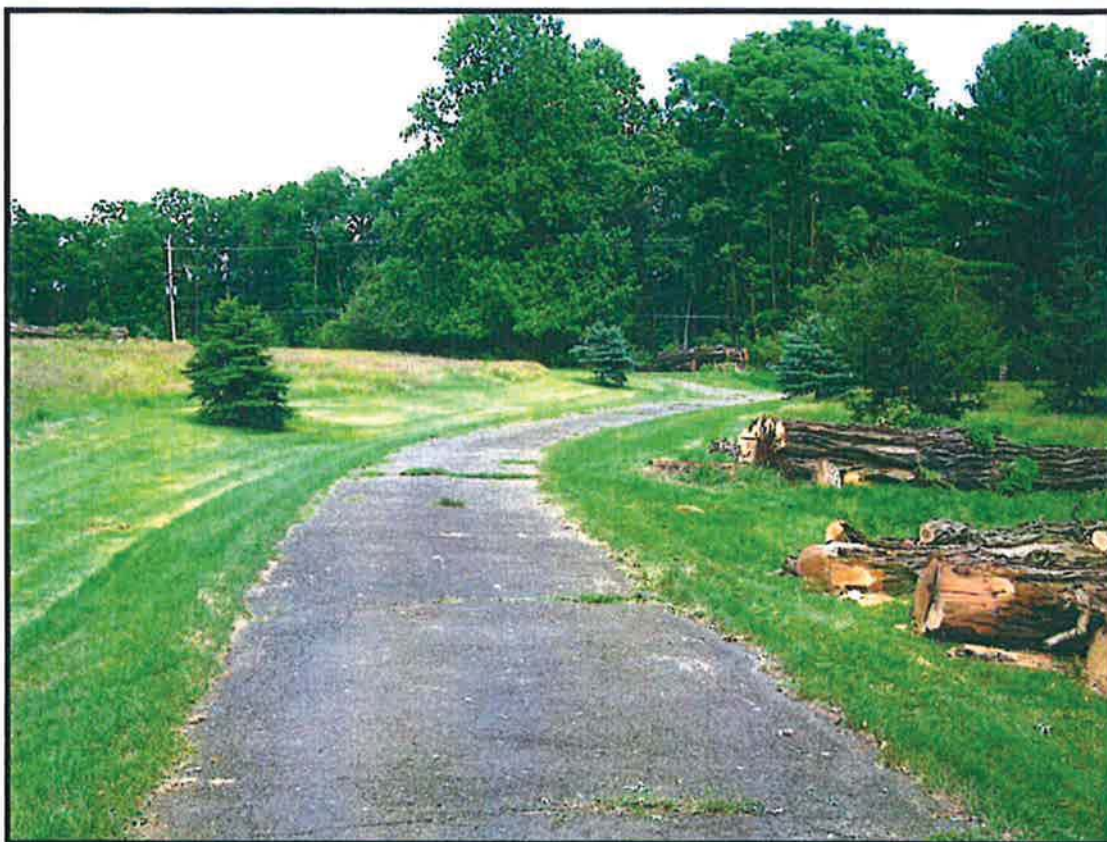
Plate 10. View east along the road in the front lawn where Shovel Tests 100-128 were excavated (Photographer: James Lee, August 2006) [HRI Neg.#06023/D2:05].

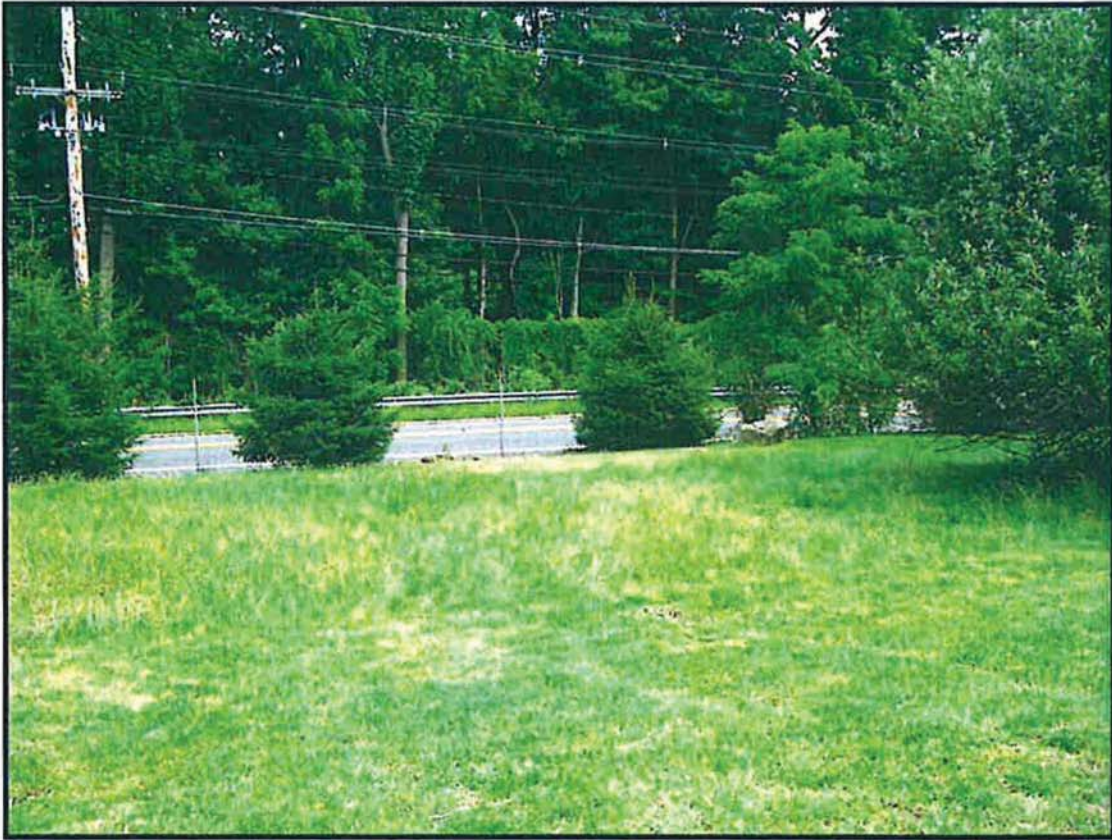
Plate 11. View southeast of the area around Excavation Unit 1 (Photographer: James Lee, August 2006) [HRI Neg.#06023/D2:20].

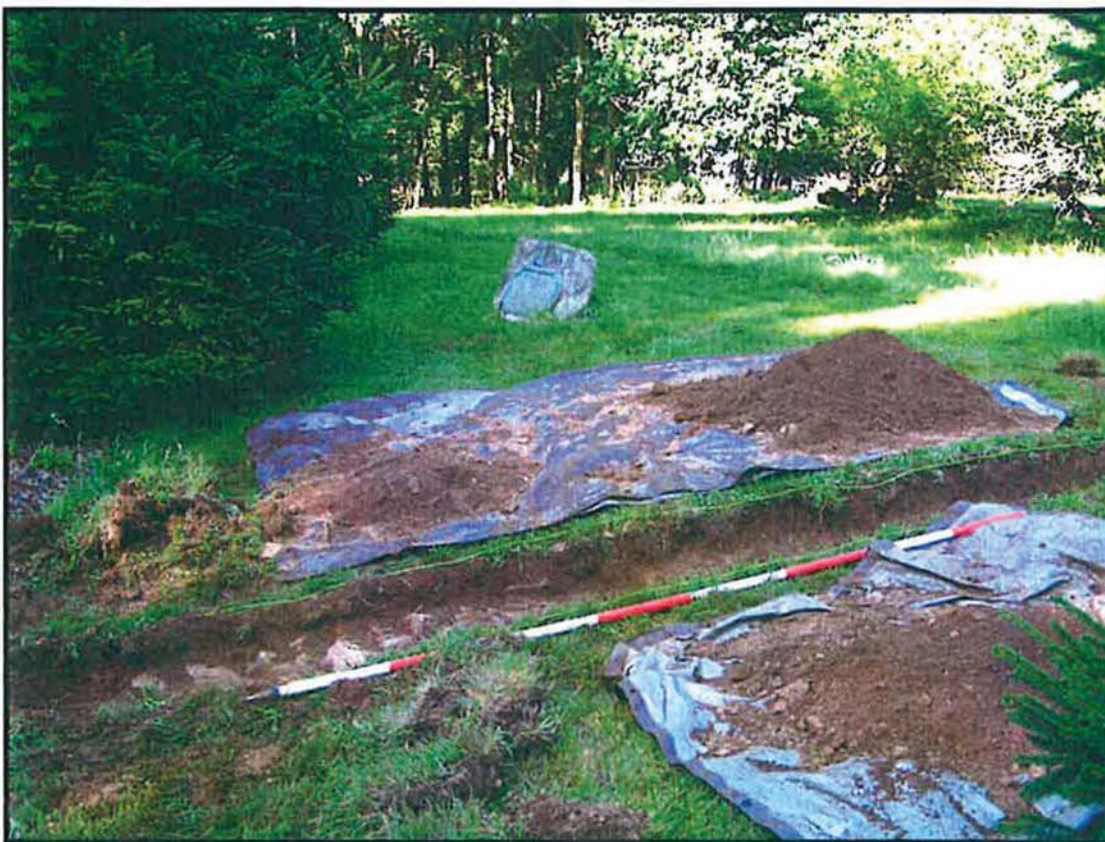
Plate 12. View south showing the completed Excavation Unit 1 (Photographer: James Lee, August 2006) [HRI Neg.#06023/D1:03].

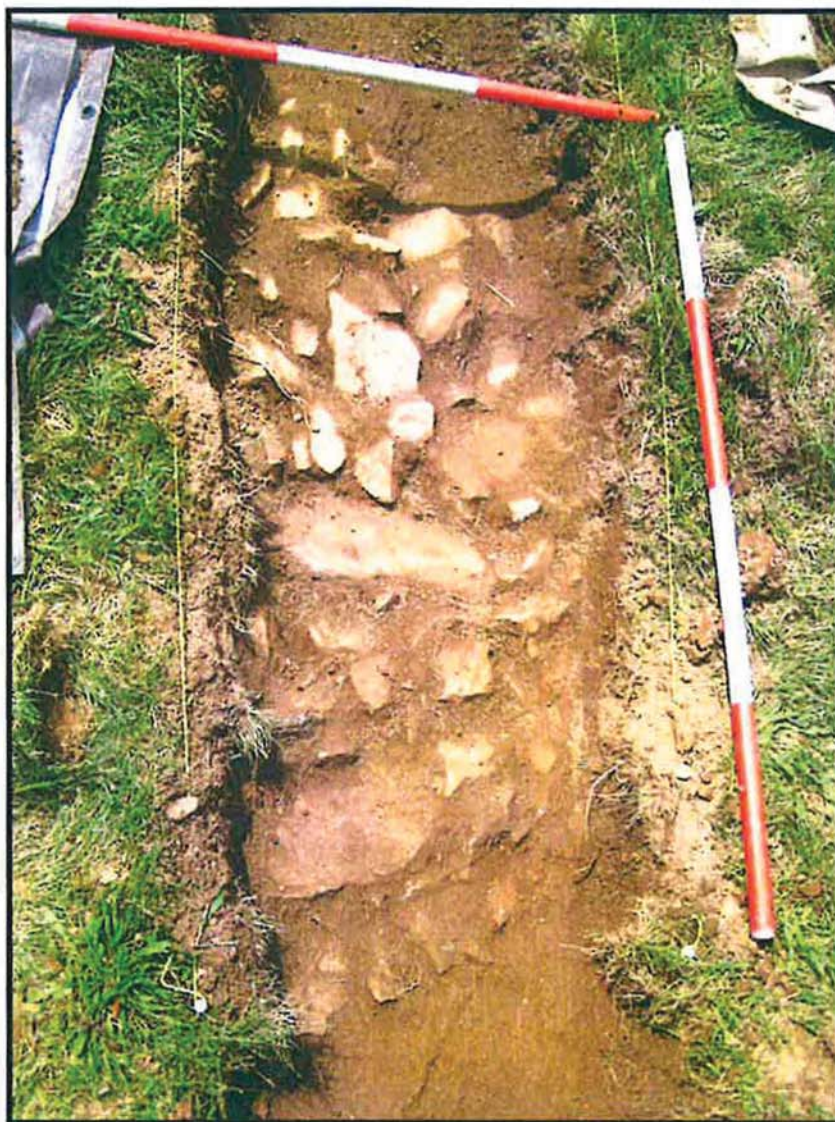
Plate 13. View west at the base of the dry-laid stone wall identified in Excavation Unit 1 (Photographer: James Lee, August 2006) [HRI Neg.#06023/D1:01].

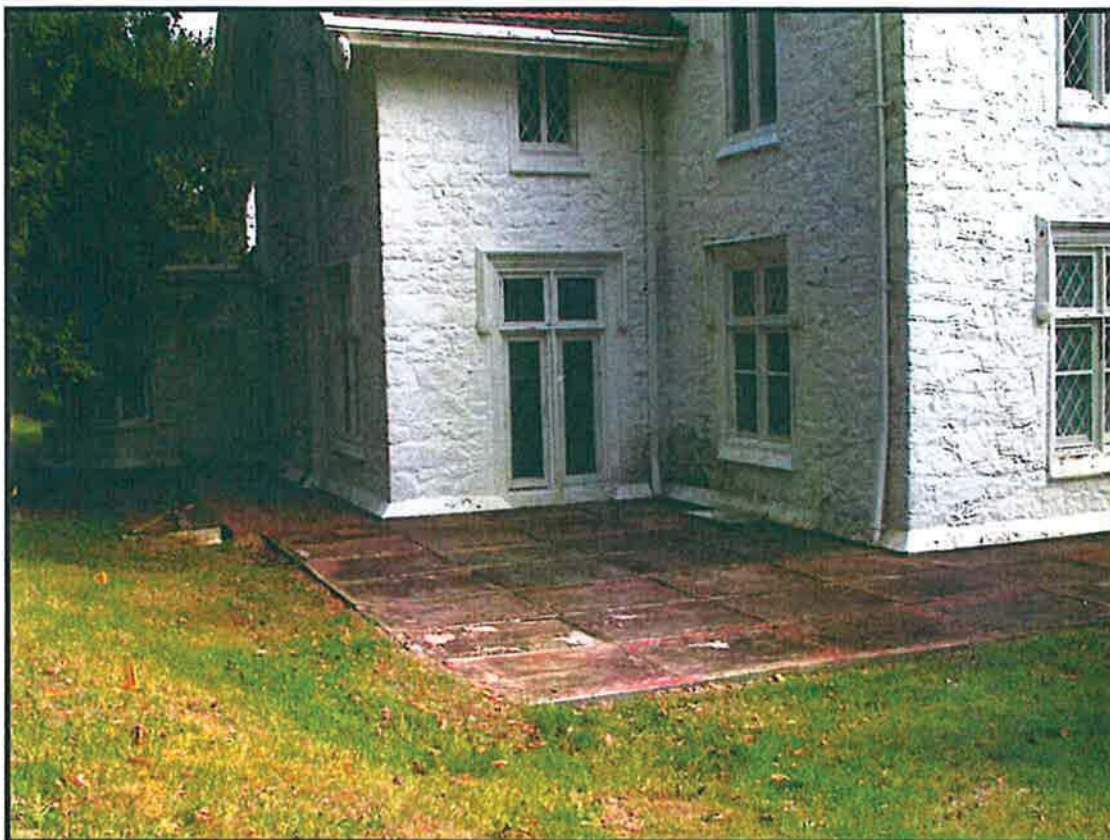
Plate 14. View east showing the rear of the house and the location of Excavation Unit 2 (Photographer: James Lee, October 2005) [HRI Neg.#05054/D1:12].

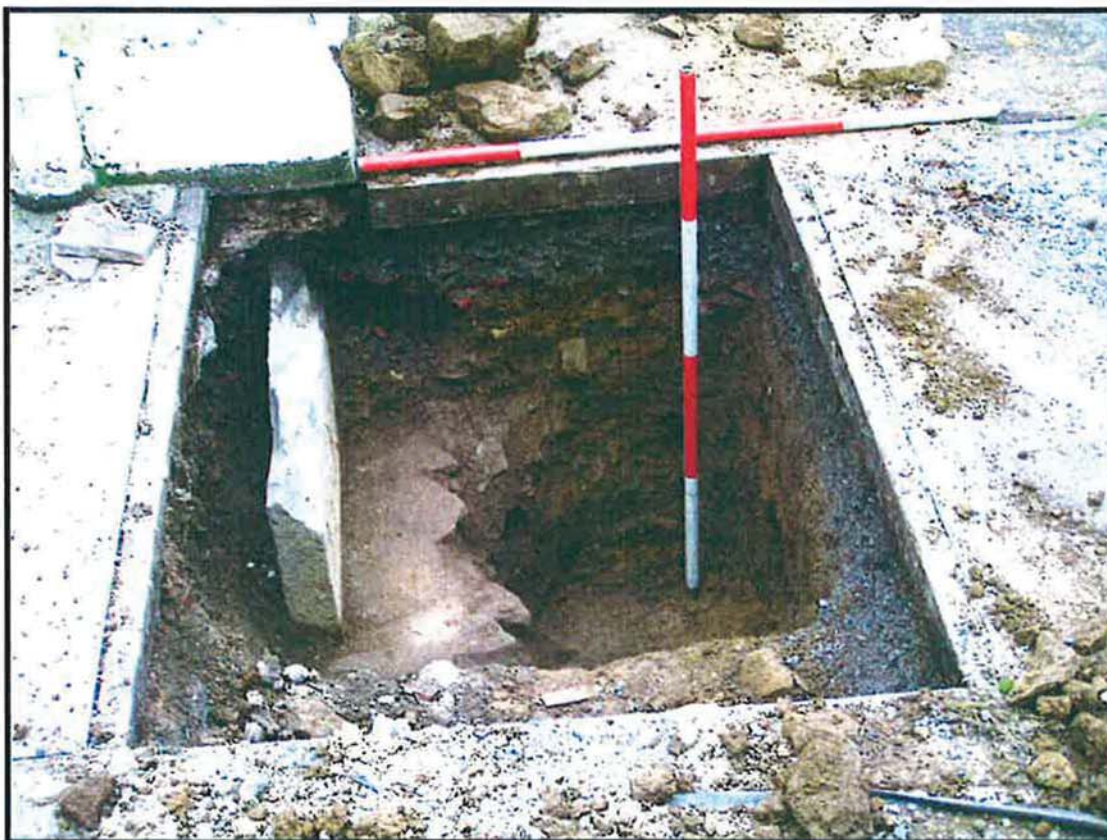
Plate 15. View southeast of the completed Excavation Unit 2 (Photographer: Andrew Martin, August 2006) [HRI Neg.#06023/D1:15].

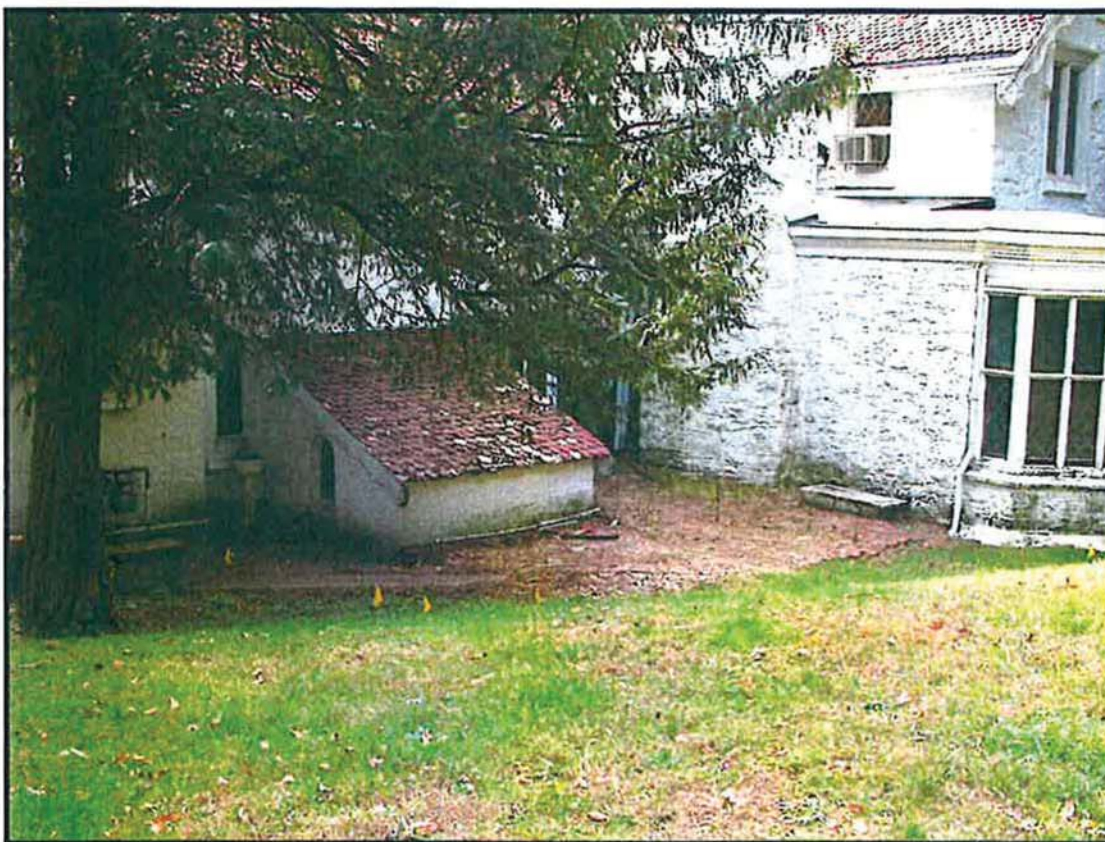
Plate 16. View south showing the location of Excavation Unit 3 (Photographer: James Lee, October 2005) [HRI Neg.#05054/D1:04].

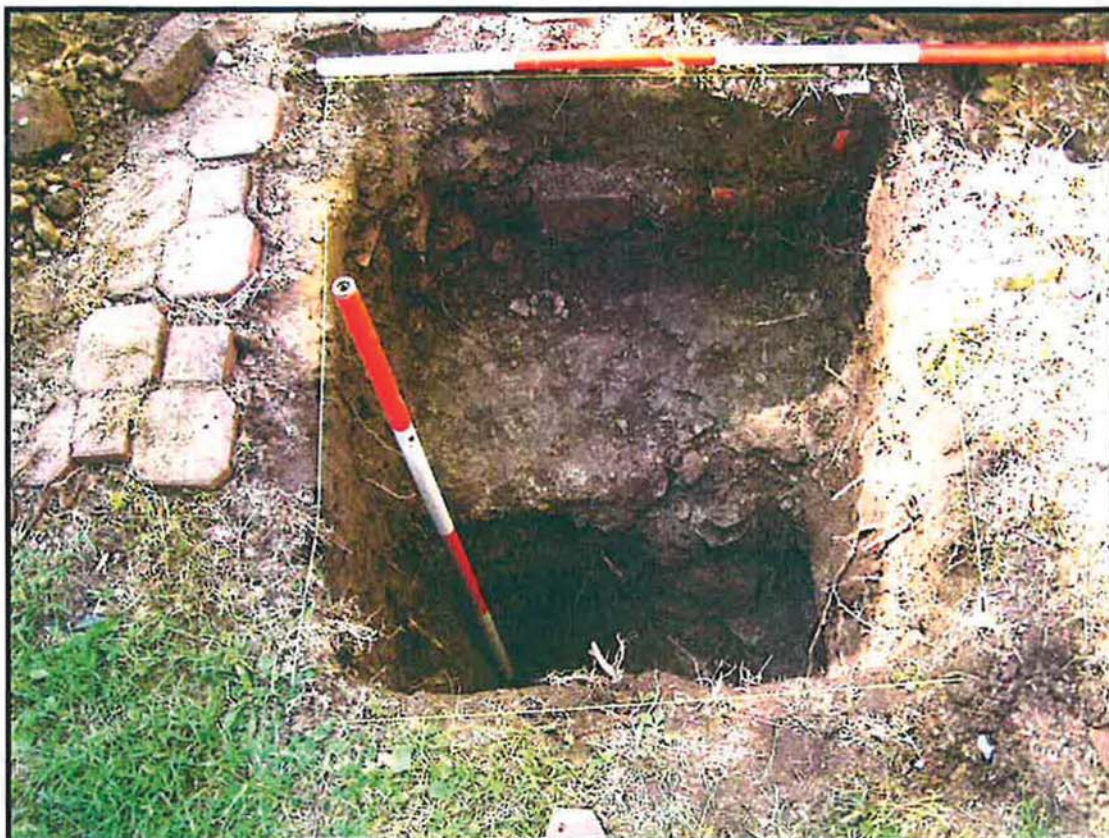
Plate 17. View southeast of the completed Excavation Unit 3 (Photographer: Andrew Martin, August 2006) [HRI Neg.#06023/D1:18].

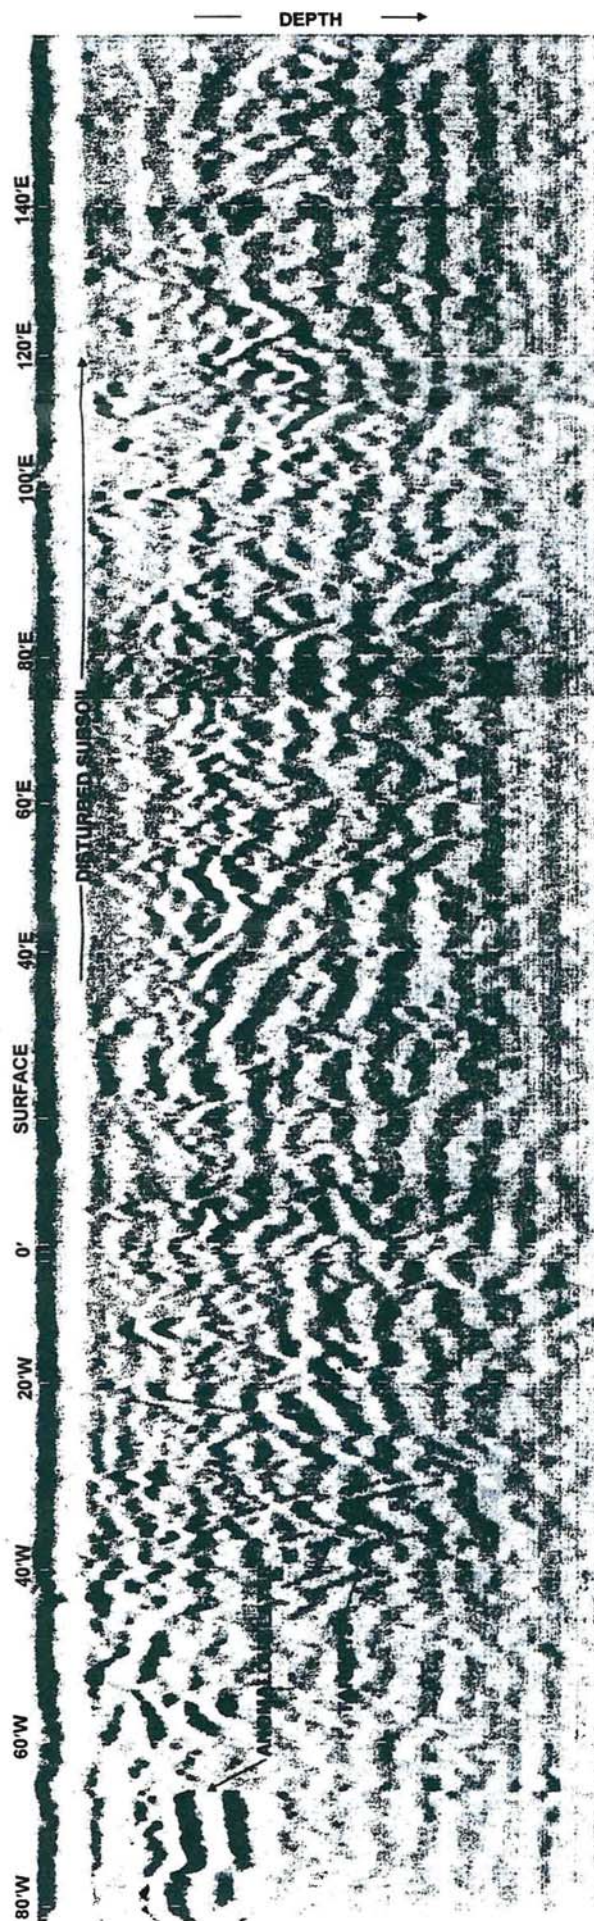
Figure 1-GPR Data Profile

GPR data profile at 170°S extending from 80°W to 160°E (GGI reference grid, refer to SAM). Shown in this profile are three distinct GPR anomalies. Three GPR-detected targets are shown centered near 19°W, 34°W, and 20°W. These targets, located within the suspected cemetery area could be graves. Estimated depth to the top of the features based on GPR data approximations is 4' to 5' below grade. Also shown, extending from approximately 65°W to 80°W is a GPR-detected anomalous subsoil layer. Estimated depth of this feature is 2' to 3' below grade. Also shown extending from 80°W to about 120°W are GPR data signatures indicative of disturbed subsoil. 200 MHz GPR antenna system, edited from 80 MHz.

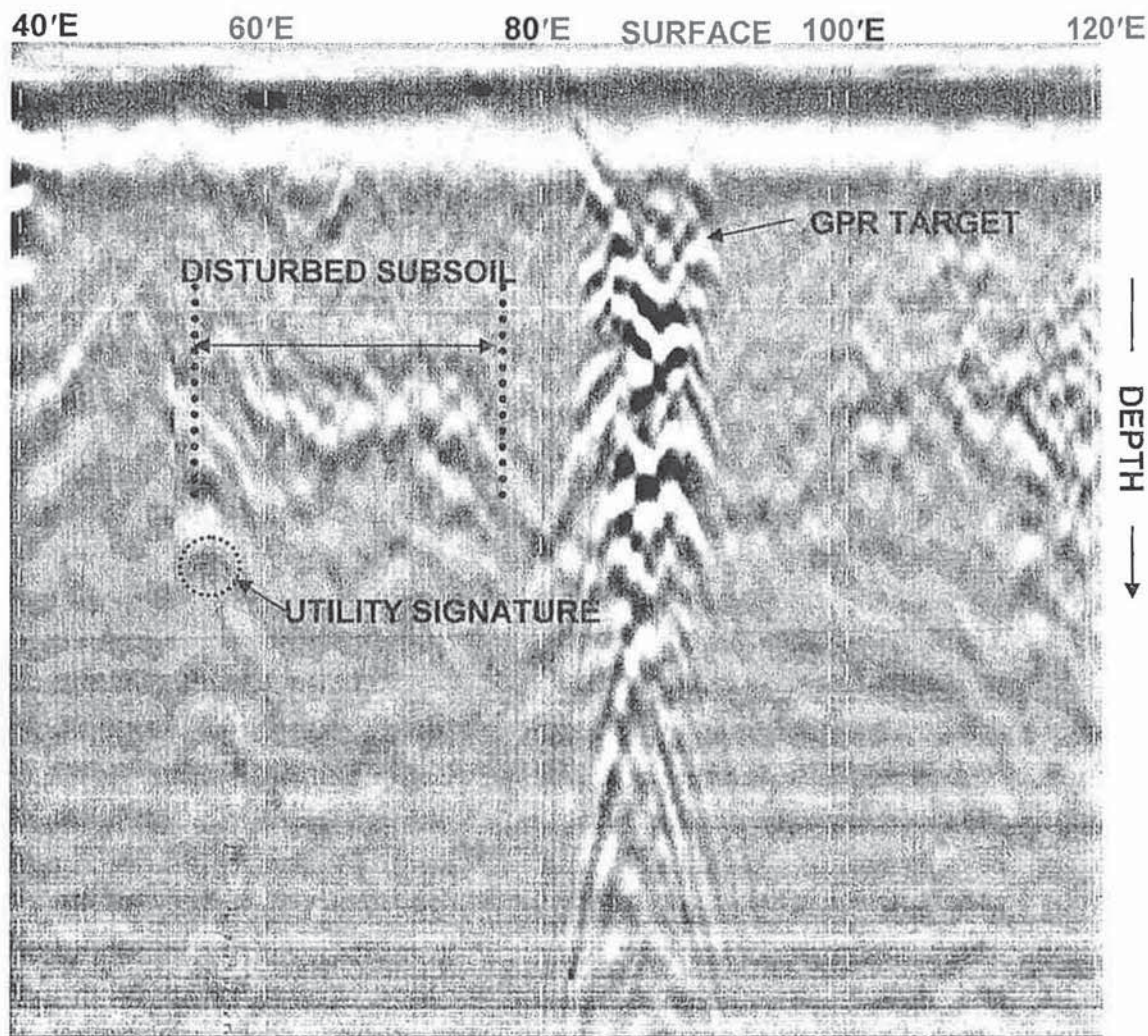
Figure 2—GPR Data Profile

GPR data profile at 280'S extending from 40'E to 120'E (GGI reference grid, refer to *SAM*). Shown in this profile is a GPR-detected target centered near 87'E which could be associated with a wall or building remnant. Estimated depth to the top of the feature based on GPR data approximations is 2' to 3' below grade. Also shown just east of the target is a section of disturbed subsoil data signatures and a deeper utility signature near 57'E. Due to the proximity of the features to one another and the location of the anomalies within the investigated area, GGI suspects these features could be associated with a former structure. 200 MHz GPR antenna system, edited from 80 ns.

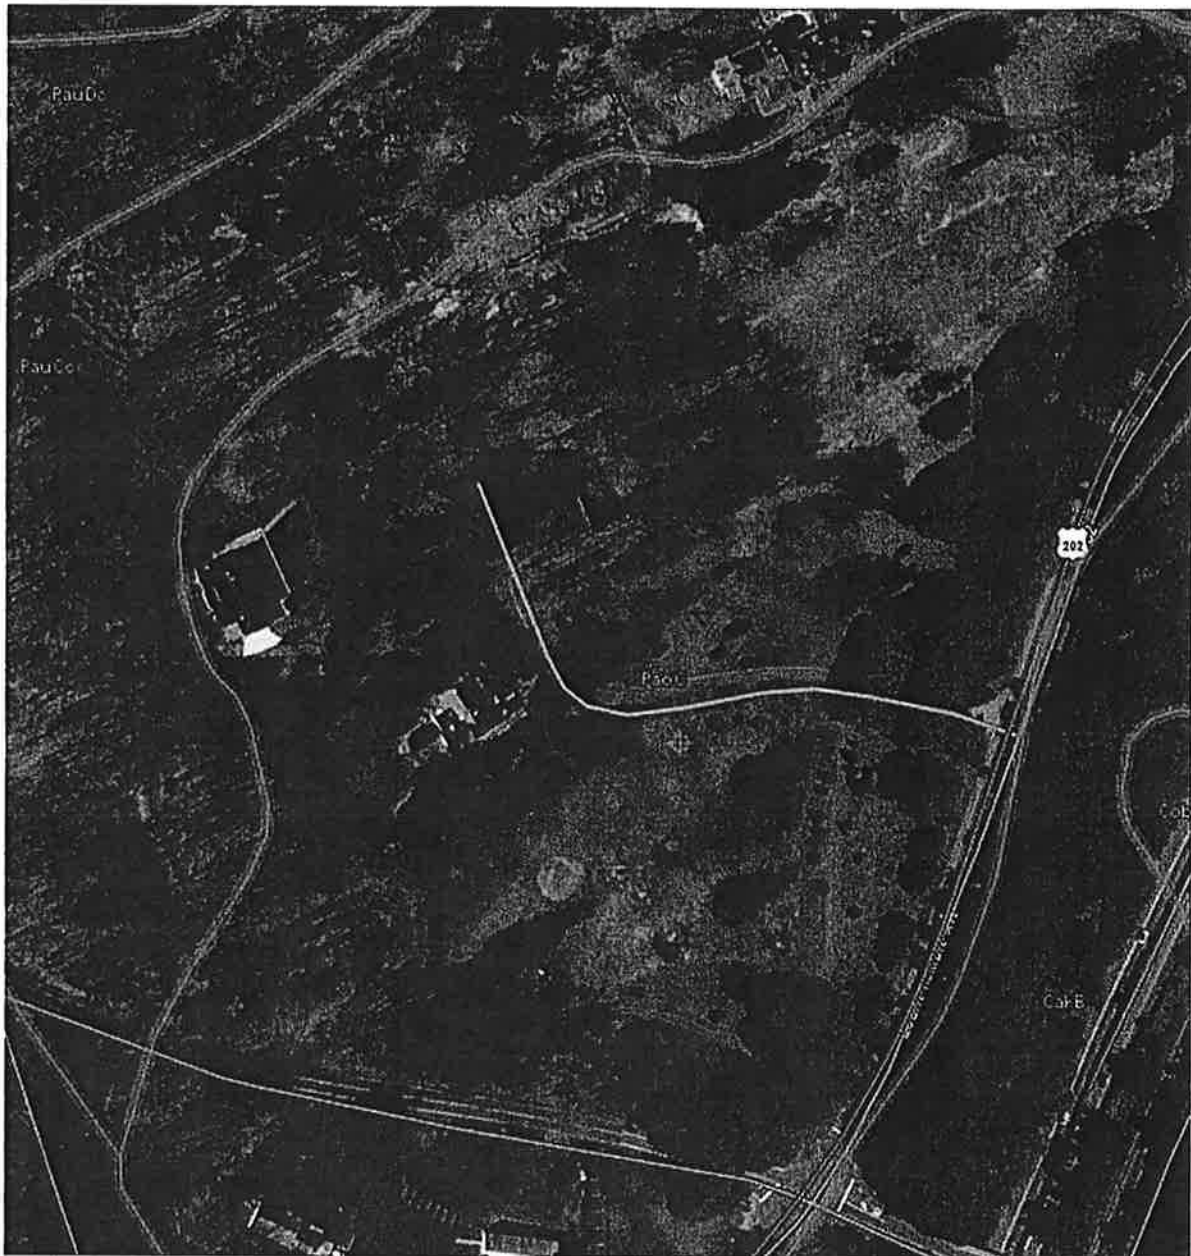
Soils Map

PaoC- Parker gravelly sandy loam, 3 to 15 percent slopes

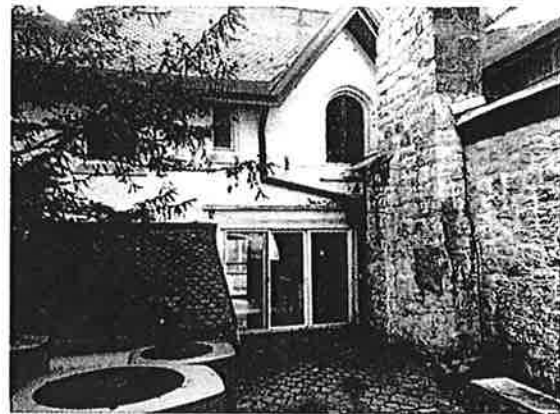
Outdoor Terrace
(Photo Taken on October 26, 2016)

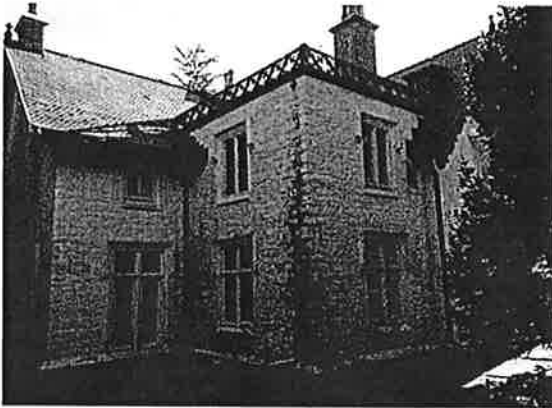
Exterior Wall
(Photo Taken on October 26, 2016)

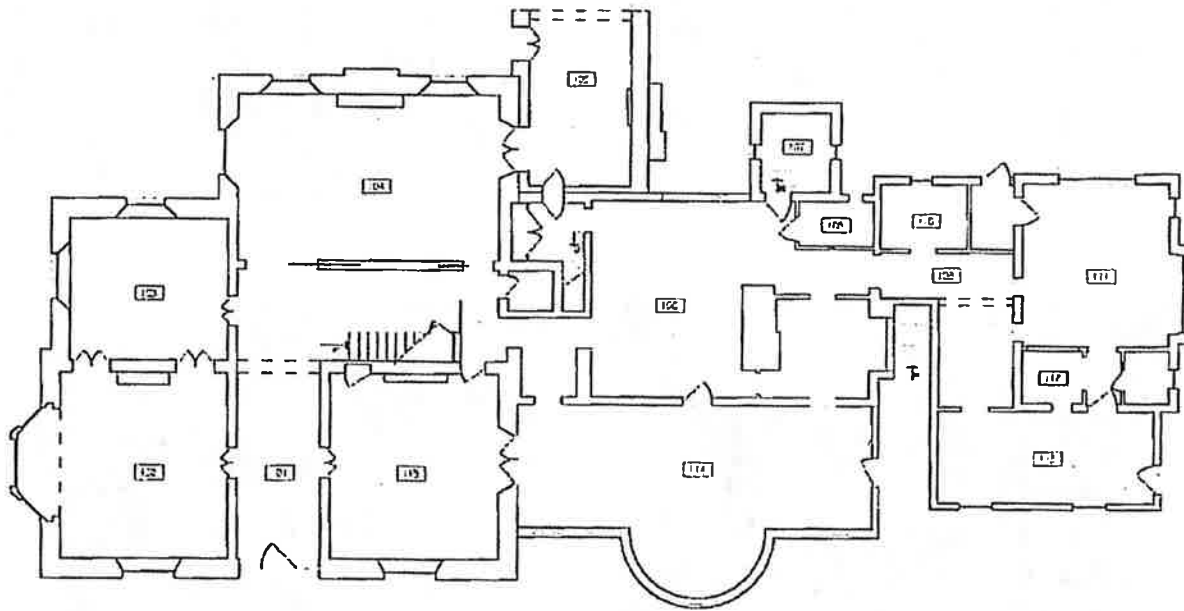
FEASIBILITY STUDY GLEN ALPIN HOUSE HARDING TOWNSHIP, NEW JERSEY	
Watson & Henry Associates Architecture and Engineering	Project Number: 04020 Drawn By: CVR
SK 1

FIRST FLOOR PLAN
SCALE: 3/32" = 1'-0"
