**APPENDIX FOR THE AREA IN NEED OF
INVESTIGATION REPORT FOR**

685 MT. KEMBLE AVE (“GLEN ALPIN”)
679 MT. KEMBLE AVENUE (“HURSTMONT”)

February 2019

Prepared by Heyer, Gruel & Associates

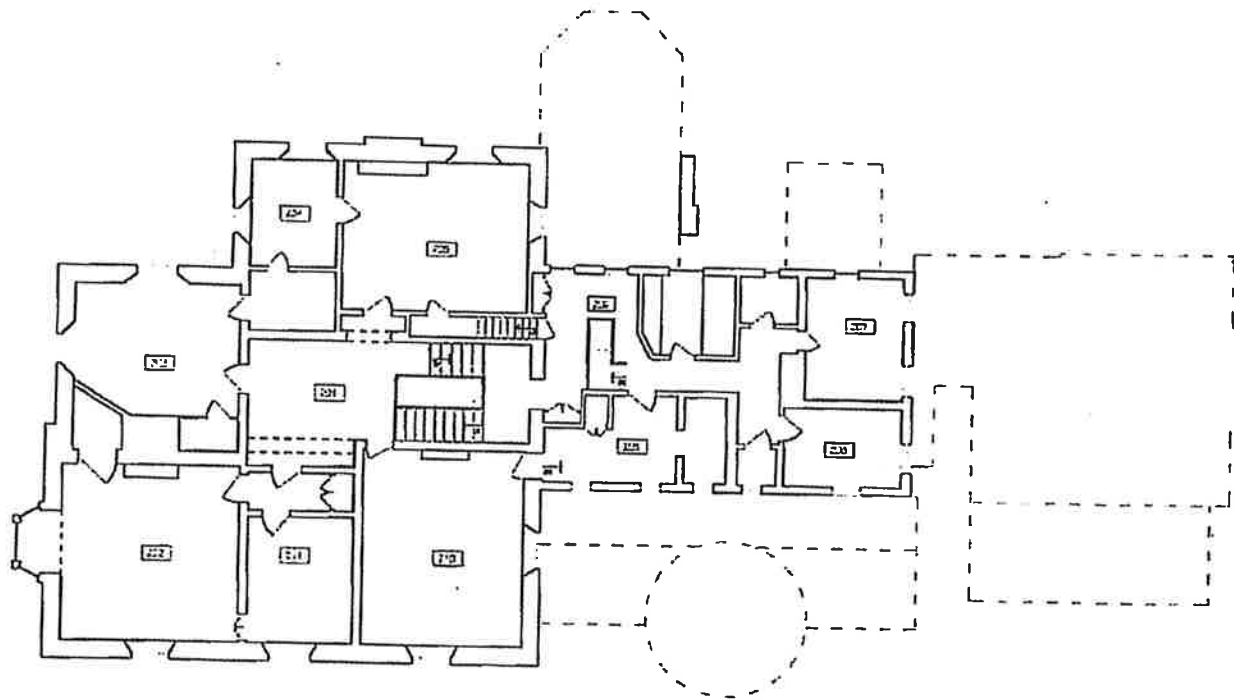
SK 2

SECOND FLOOR PLAN

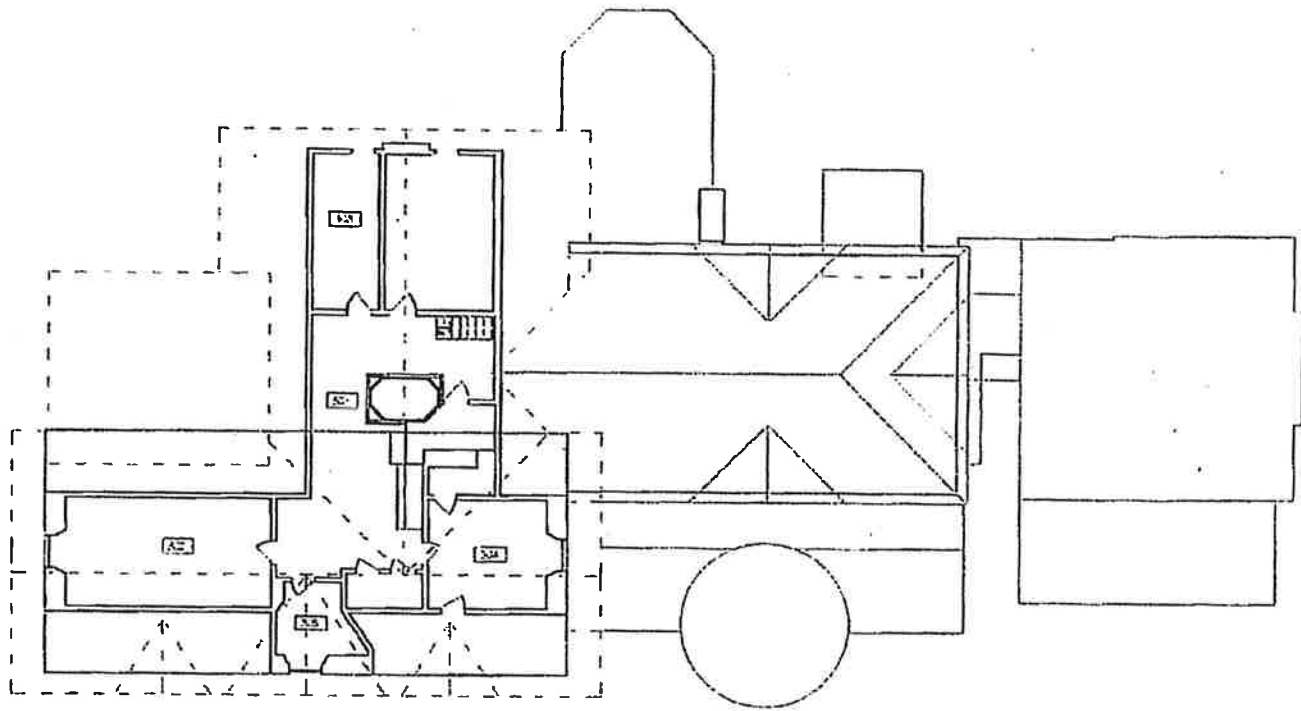
SK 3

THIRD FLOOR PLAN

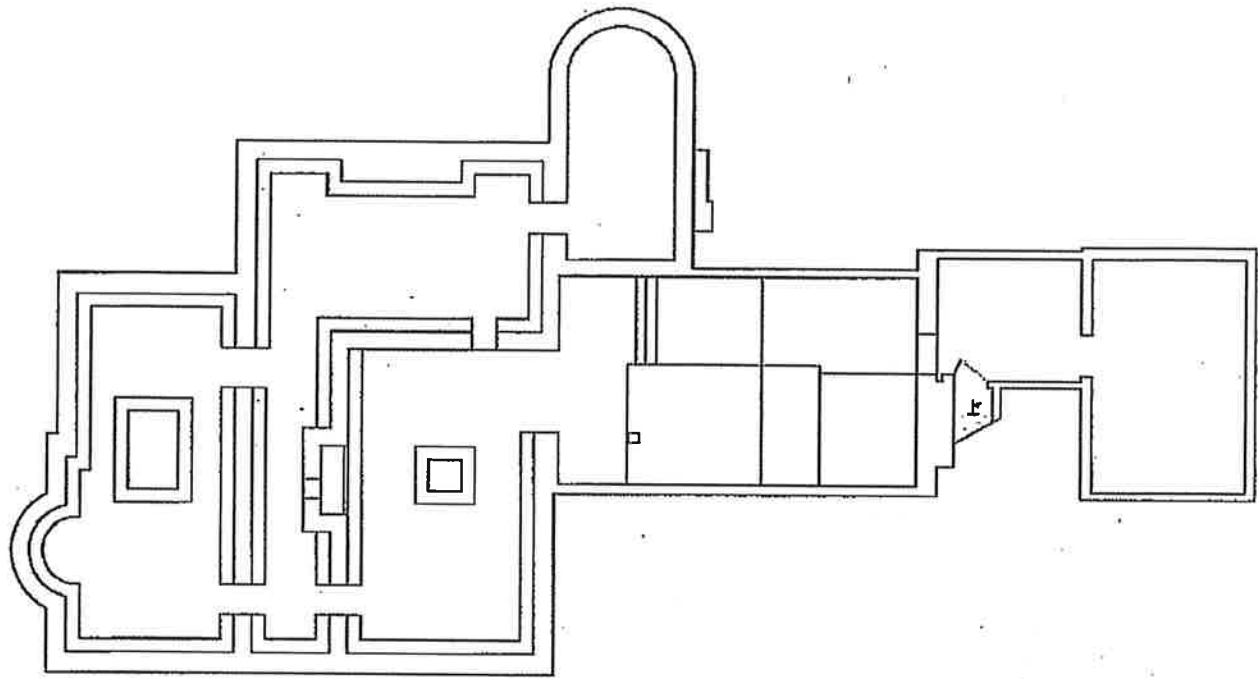
**BASEMENT PLAN**
