TREE SURVEY AND REMOVAL PLAN

SITE NAME: HARDING 3

8 MILLBROOK ROAD,
TOWNSHIP OF HARDING,
MORRIS COUNTY, NEW JERSEY 07976
BLOCK: 17 LOT: 1

DRAWING NO. L-1
SHEET NO: 9 OF 11
PRINT DATE: 03/06/23

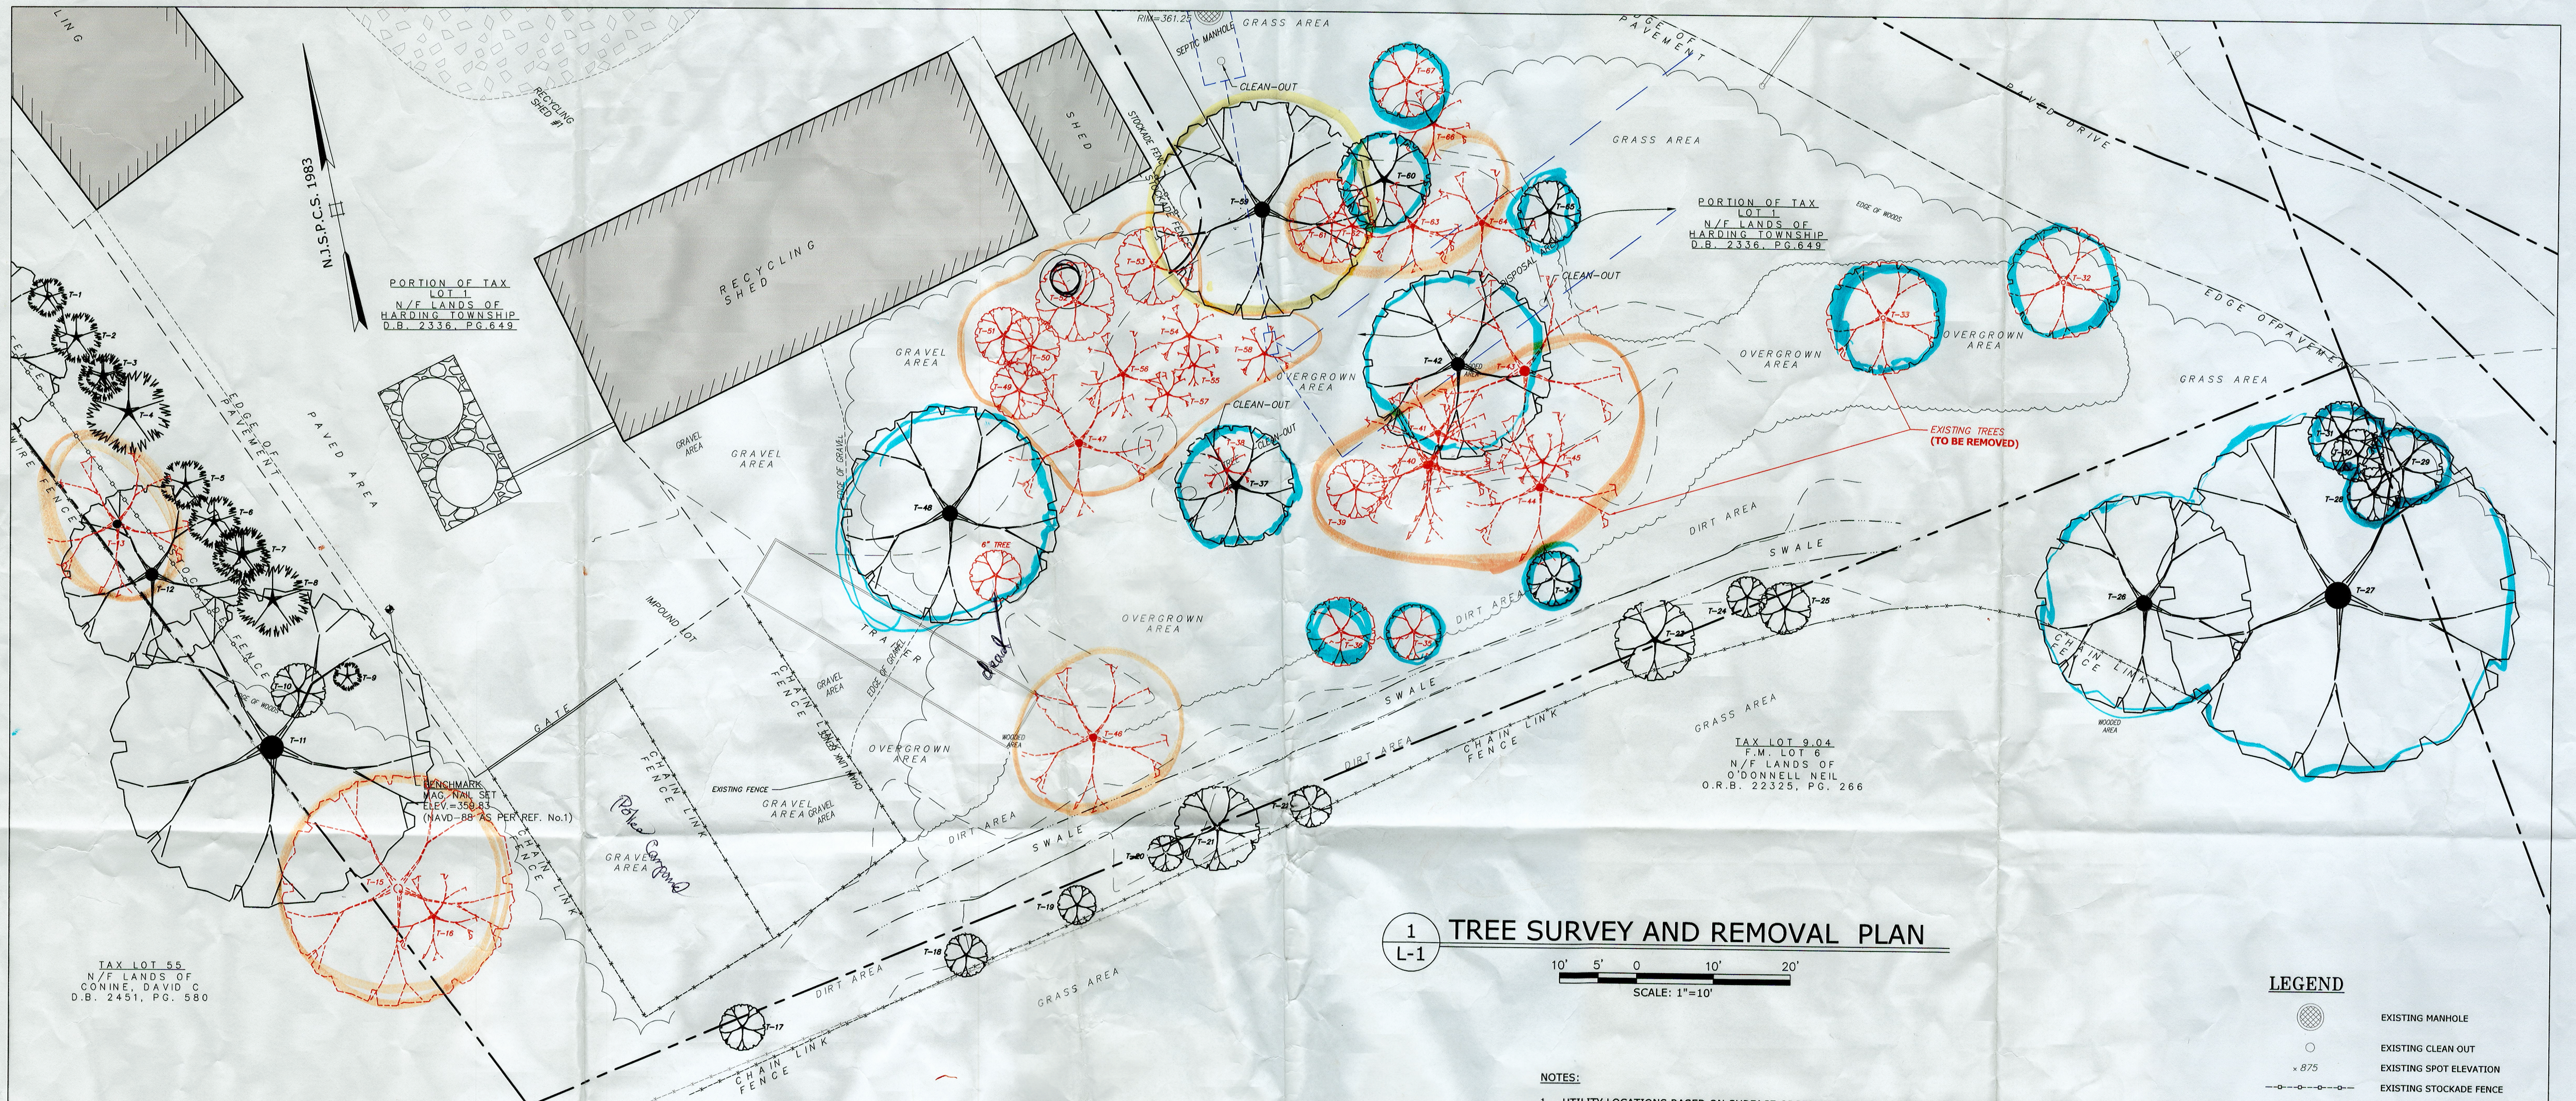
1 L-1 TREE SURVEY AND REMOVAL PLAN 10' 5' 0 10' 20' SCALE: 1"=10'

- ALL SHOWN ELEVATIONS BASED UPON NAVD-88 AS PER REF. NO. 1 ON SHEET SP-1.
 - CONTRACTOR TO REMOVE ALL DEAD, DYING, INVASIVE TREES, AND TREE 50, 51 AND 52 (TO FACILITATE COMPOUND CONSTRUCTION) AS NOTED IN THE PLANT LIST AND THE LANDSCAPING PLAN. CONTRACTOR IS RESPONSIBLE FOR CORRECT IDENTIFICATION OF TREES TO BE REMOVED. ALL TREES NOT SPECIFIED TO BE REMOVED SHALL BE LEFT IN THEIR EXISTING CONDITION AND SHALL NOT BE DAMAGED DURING TREE REMOVAL ACTIVITIES. TREES TO BE REMOVED SHALL BE REMOVED FROM THE SITE AND DISPOSED OF IN ACCORDANCE WITH ALL APPLICABLE REGULATIONS.

- IN ADDITION TO TREE REMOVAL AS NOTED, CONTRACTOR TO REMOVE ALL INVASIVE SHRUBS AND VINES LOCATED WITHIN THE AREA TO BE LANDSCAPED. SPECIES INCLUDE BURNING BUSH, EUROPEAN PRIVET, MULTIFLORA ROSE, AMUR HONEYSUCKLE, JAPANESE HONEYSUCKLE, ENGLISH IVY, AND EURASIAN BITTERSWEET. SPECIES TO BE REMOVED AND ERADICATED. CONTRACTOR RESPONSIBLE FOR CORRECT IDENTIFICATION OF INVASIVE TO BE REMOVED. INVASIVE TO BE REMOVED SHALL BE REMOVED FROM THE SITE AND DISPOSED OF IN ACCORDANCE WITH ALL APPLICABLE REGULATIONS.
